# NHTSA RECALL NOTICE #05E-064 - MIGHTYJOE 2 & 3

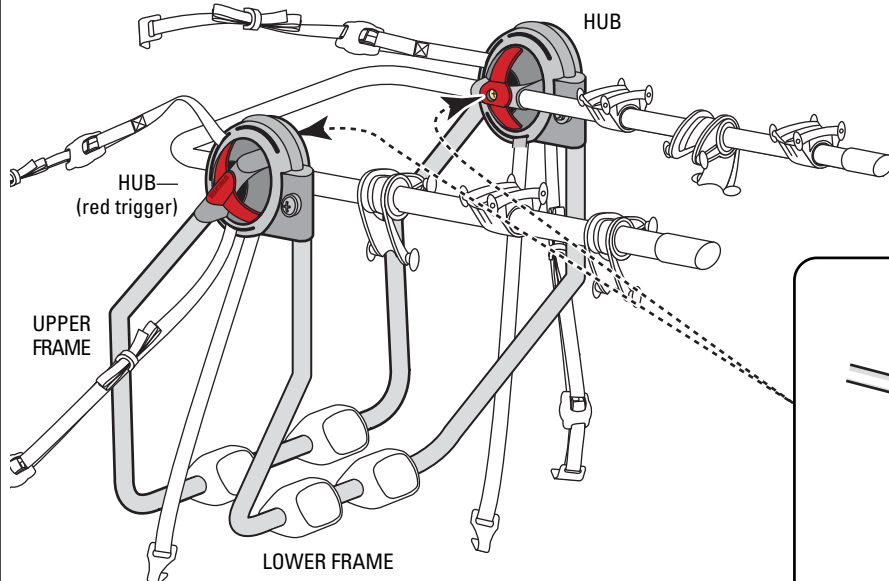
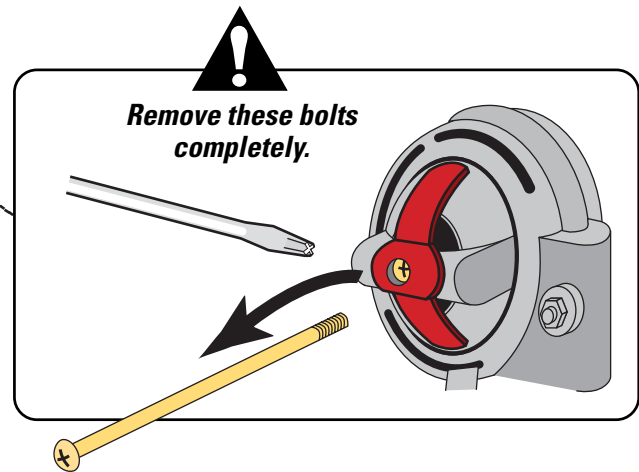
- 2** **LOOSEN THE BOLTS INSIDE THE INNER HUBS.**

**TOOL REQUIRED:**  
Phillips screwdriver  
(crosshead)

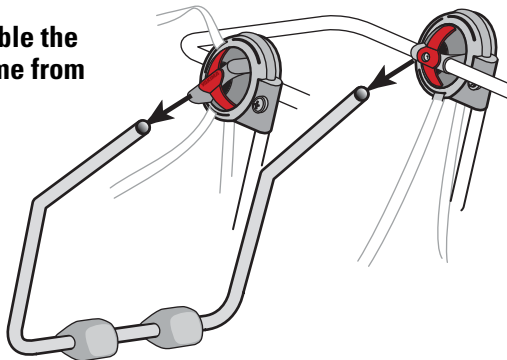
- 3** **Disassemble the upper frame from the hubs.**

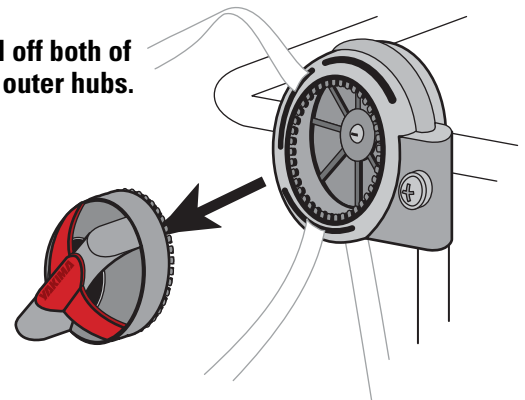
- 4** **Pull off both of the outer hubs.**

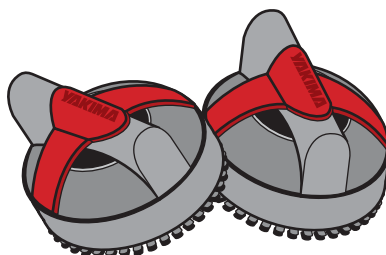
- 5** **Ship the two hubs in the pre-paid addressed mailer.**

*Hubs have red triggers, black body with gear teeth below.*

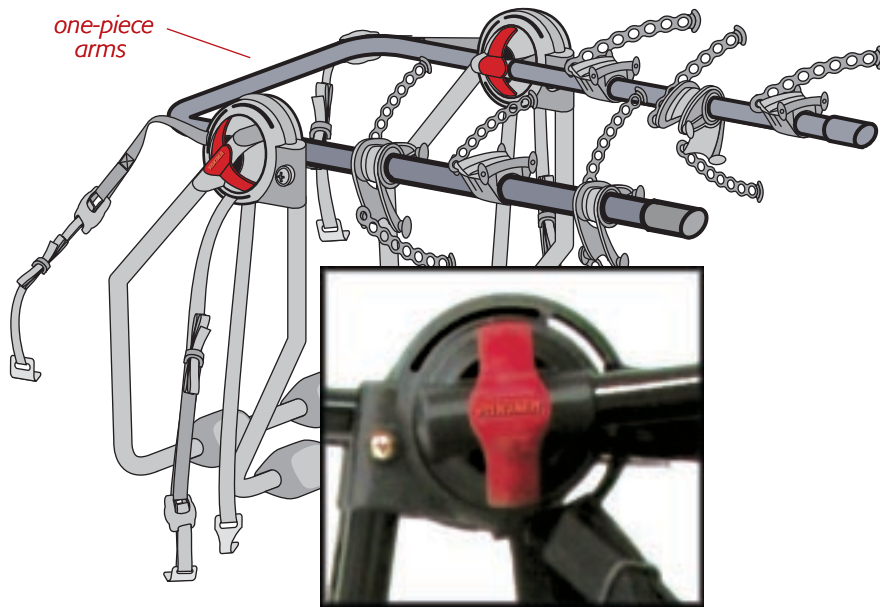
### MightyJoes 2005

**MightyJoe 2 - # 02609**

**MightyJoe 3 - # 02608**

ONLY THE 2005 MIGHTY JOE PRODUCTS ARE BEING RECALLED.

The 2005 Mighty Joe design has characteristic round hubs with quick release triggers on both sides of the hubs.

The bars that carry bikes are connected directly to the round hub, and pivot on this hub. The point between bars and hubs is the design that is being recalled.

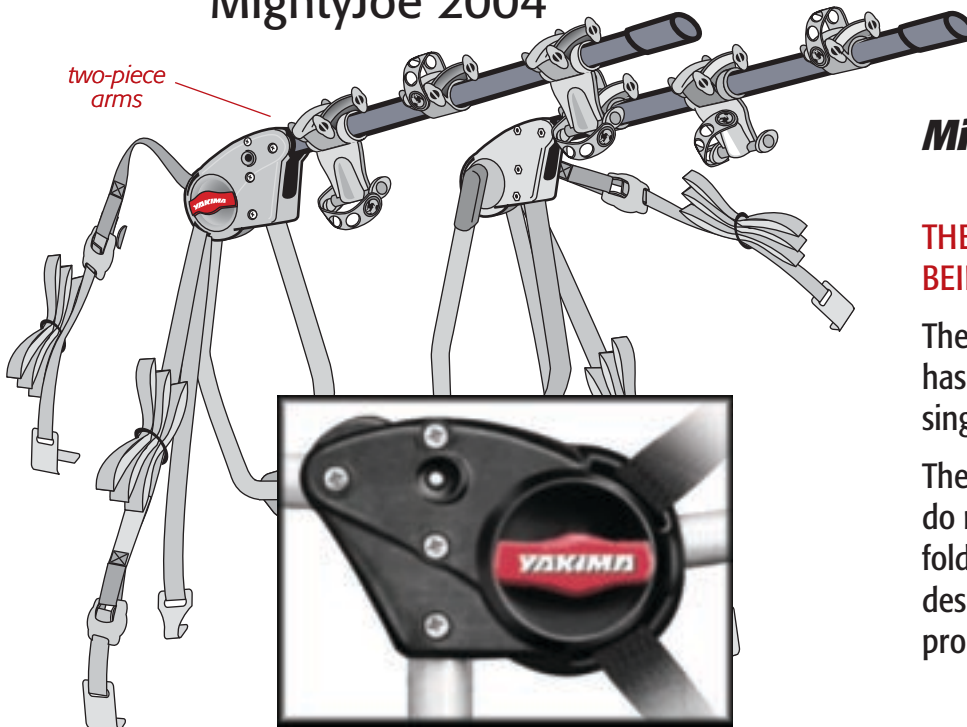
### MightyJoe 2004

**MightyJoe - # 02607**

THE 2004 MIGHTY JOE IS NOT BEING RECALLED.

The 2004 Mighty Joe design has large molded hubs with a single trigger on each hub.

The bars that hold the bikes do not pivot on the hub, but fold down independently. This design continues to function properly.
